Manhole Inspection Summary

Manhole # S05WW1019MH

Location Address: **5800 ETHELBERG AVE**

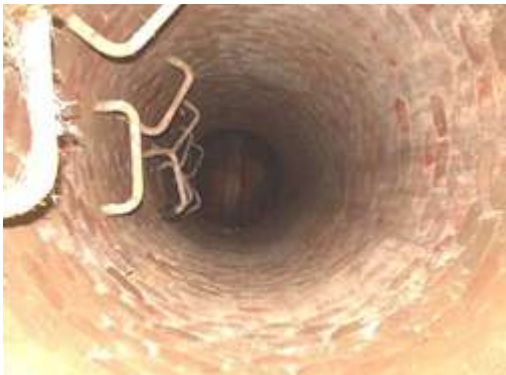
Top View

Adjustment infiltration. Bench debris.

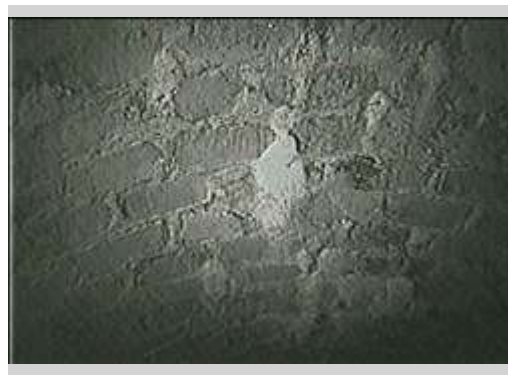
Defect

Barrel infiltration.

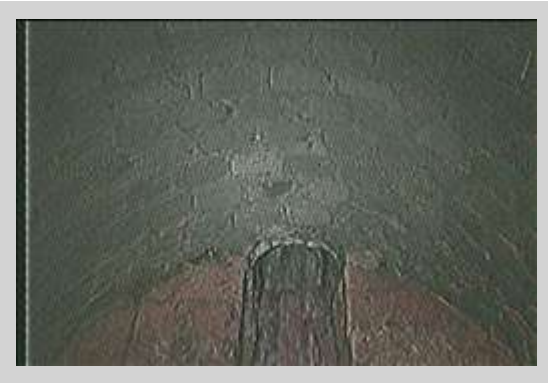
8 in. Circular Gravity Sewer Pipe Out @ 12 O'Clock

Infiltration: **Evidence** Pipe Seal Cond: **Unknown**

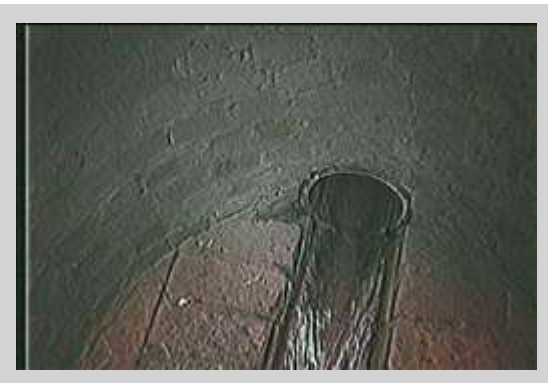
8 in. Circular Gravity Sewer Pipe In @ 6 O'Clock

Bench deterioration.

Infiltration: **Evidence** Pipe Seal Cond: **Unknown**
